DEPARTMENT OF TRANSPORTATION

Contract #: 04-0120F4Cty: SF/ALA Rte: 80 PM: 13.2/13.9File #: 99.28**WELDING INSPECTION REPORT****Resident Engineer:** Casey, William**Address:** 333 Burma Road**City:** Oakland, CA 94607**Report No:** WIR-027669**Date Inspected:** 08-May-2012**Project Name:** SAS Superstructure**Prime Contractor:** American Bridge/Fluor Enterprises, a JV**Contractor:** Lubrite Industries**OSM Arrival Time:** 700**OSM Departure Time:** 1530**Location:** Meadville PA**CWI Name:** Brad McWright**CWI Present:** Yes No**Inspected CWI report:** Yes No N/A**Rod Oven in Use:** Yes No N/A**Electrode to specification:** Yes No N/A**Weld Procedures Followed:** Yes No N/A**Qualified Welders:** Yes No N/A**Verified Joint Fit-up:** Yes No N/A**Approved Drawings:** Yes No N/A**Approved WPS:** Yes No N/A**Delayed / Cancelled:** Yes No N/A**Bridge No:** 34-0006**Component:** Spherical Bearing Hinge K**Summary of Items Observed:**

This Quality Assurance Inspector (QAI) arrived at Lubrite Industries (LI), Meadville PA, as requested to monitor the continuation of welding of the Anchor Studs to the Anchor Plates for Bearing Assemblies HK1 and HK2.

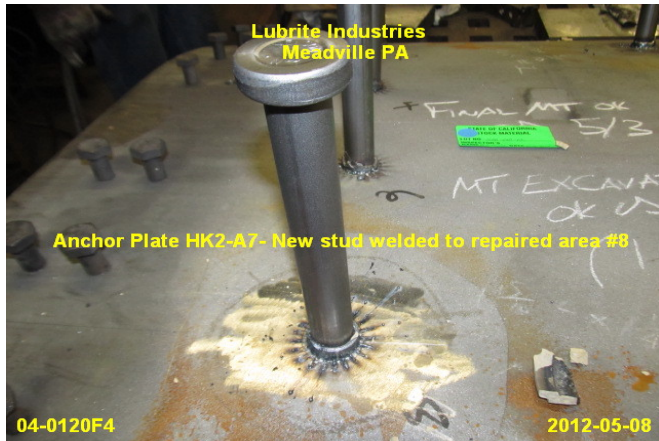
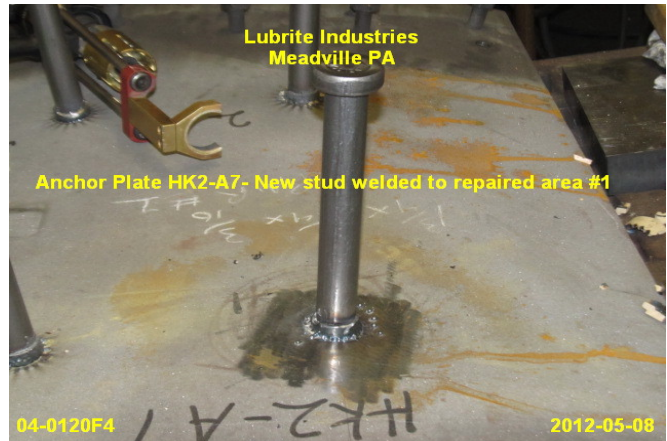
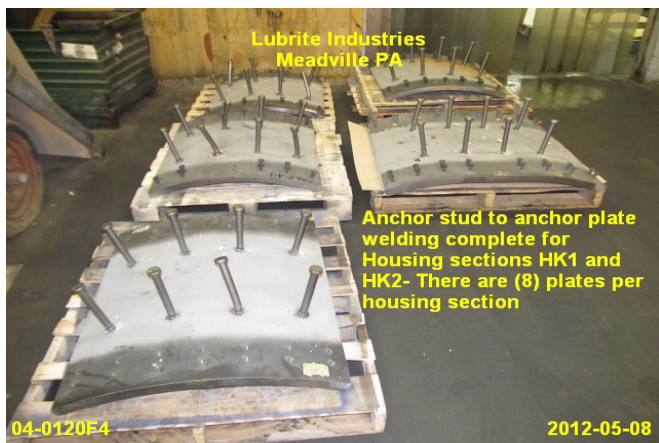
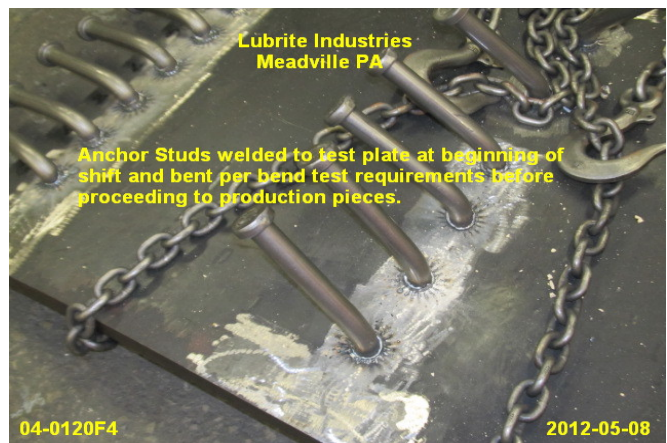
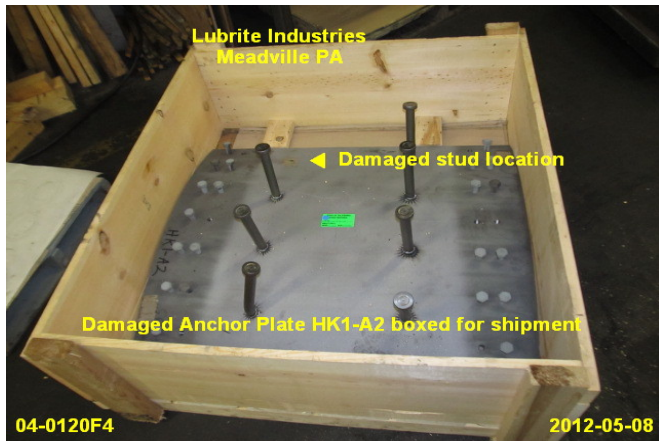
Upon arrival this QAI met with Third Party QC Reno Davis KTA (TPQC), and Brad McWright (LIQC). First Anchor Plate was set up and locations marked for attachment of anchor studs to plate. The plate material is ASTM A709 Grade 50 Heat 0502434. Anchor studs are 1" x 8 1/4" ASTM A108/A29 Grade 1015 Heat 5093721. The original qualified stud gun was set up for use due to the previous day malfunction of the new equipment.

Qualified LI Welder then proceeded to weld (3) test studs to a sample plate and perform bend test on all three before proceeding to production pieces. The first production piece was set up and (8) Anchor studs were welded to the Plate with no failures. Welds were inspected by TPQC and witnessed by this QAI. Visual inspection revealed no surface defects. The TPQC requested a bend test be performed on one stud for verification of full fusion. Stud was bent 15 degrees with no sign of tearing from base metal. The welder then proceeded to weld the anchor studs to the remainder of the anchor plates. Plate HK2-A7 was returned from repairs performed at American Bridge, Coraopolis PA and (2) new studs were welded to plate.

The damaged Anchor plate HK1-A2 was boxed, Green tagged with blue dot and shipped to American Bridge in Coraopolis, PA for repairs. The assigned Lot Number is S26-012-12.
